**HIGH TEMPERATURE (1200°C)
CERAMIC-TO-METAL SEAL
DEVELOPMENT**

R. L. McKisson and G. Ervin, Jr.

Atomics International
North American Rockwell

**NATIONAL AERONAUTICS AND SPACE ADMINISTRATION
NASA LEWIS RESEARCH CENTER
Under Contract No. NAS3-11840**

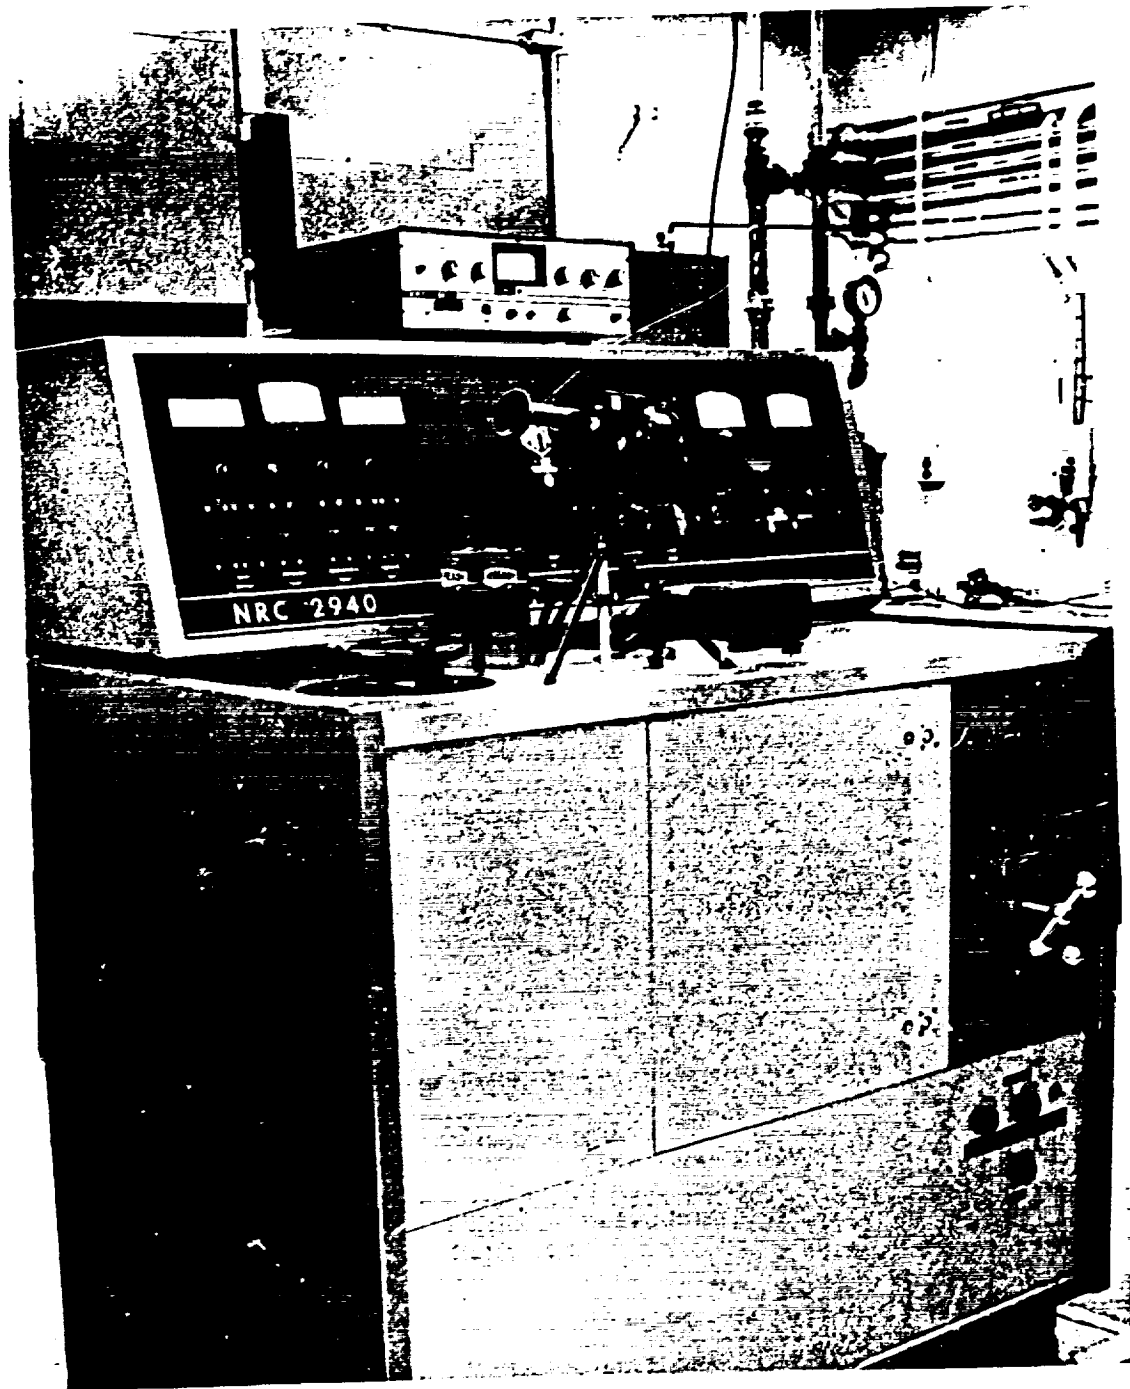
Figure 31. Brazing Furnace

Brazing Furnace. — The brazing furnace is a commercial unit manufactured by National Research Corporation, and is fitted with a liquid N₂ cold-trapped oil diffusion pump vacuum system. The heating element is a horizontally mounted tantalum strip formed into a 4-1/2 inch (11.4 cm) diameter circle, and powered by a step-down transformer, with a manual 23.5 KVA auto transformer control. This unit is shown in Figure 31.

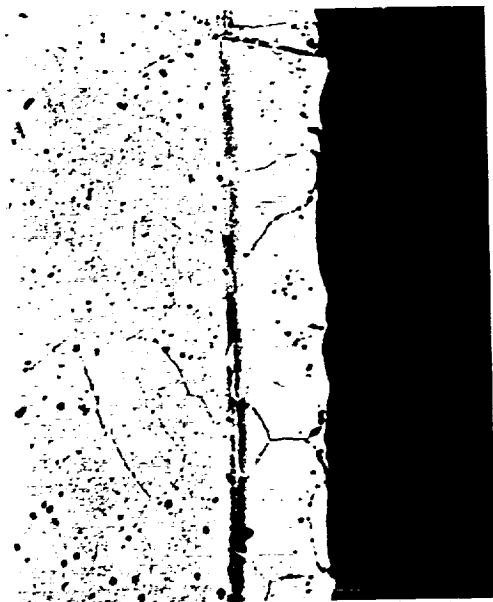
A. Micrograph, 100X

Figure 49. Braze Analysis Data: Braze System 3M (Cb-1Zr/V-2Ce/Mo/Al₂O₃) brazed at 1860° C for 60 s. Sample A aged for 10 hrs (3.6×10^4 s) at 1200° C; Sample B aged for 100 hrs (3.6×10^5 s) at 1200° C.

The braze layer in the 100-hour (3.6×10^5 s) aged B sample shown in Figure 49 is quite wide, and the demarcation between the braze and the Cb-1Zr is less pronounced, although the braze thickness is about 8 mils (0.203 mm). The braze DPH hardness is nominally 300 units, and that of the Cb-1Zr alloy is, again, 75 units. A rather level microhardness profile is found, with only a slight hardness increase at the Al_2O_3 -braze interface.

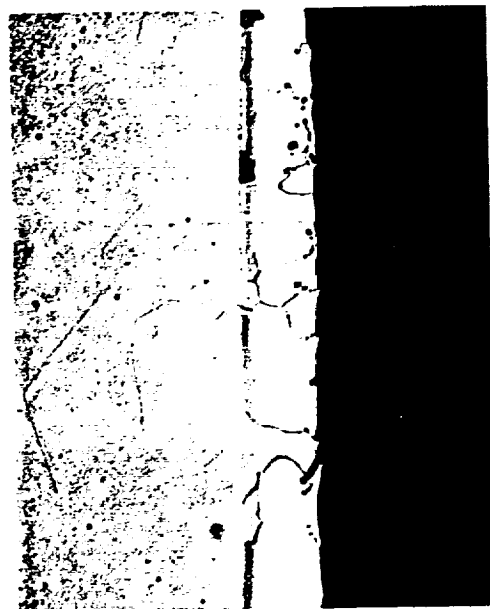
Figure 62. Braze Analysis Data. Braze System 4M
(Cb-1Zr/V-2Hf/Mo/Al₂O₃) brazed at 1860°C for 1 minute.

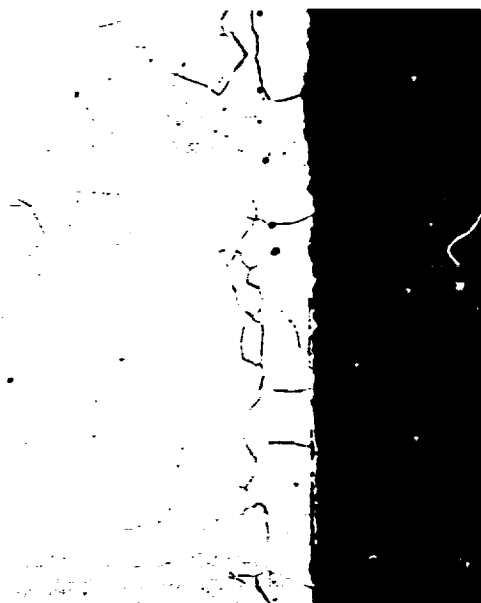
Figure 88. Braze Analysis Data: Braze System 9M (Cb-1Zr/64V-34Cb-22Zr/Mo/Al₂O₃) brazed at 1860°C for 60 s. Sample A aged for 10 hrs (3.6×10^4 s) at 1200°C; Sample B aged for 100 hrs (3.6×10^5 s) at 1200°C.

Braze system 9M (Cb-1Zr/64V-34Cb-2Zr/Mo/ Al_2O_3): An examination of Figure 88, the data for Braze System 9M shows the thickness of the 10-hour (3.6×10^4 s) aged A sample to be about 2 mils (0.0508 mm) including a nominal 0.5 mil (0.0127 mm) reaction zone at the Al_2O_3 interface. Epitaxy is evident. The DPH hardness of the interface layer is 750, that of the mid-region of the braze is 450 and the Cb-1Zr alloy shows 75, as usual.

The braze layer in the 100-hour (3.6×10^4 s) aged B sample in Figure 88 appears to be about 5 mils (0.127 mm) thick. No interface layer at the Al_2O_3 is present. The grain pattern suggests such a region at the Cb-1Zr-braze juncture, although no indication of a hardness effect is seen. The hardness profile rises from the typical DPH value of 75 in the Cb-1Zr to 425 near the Al_2O_3 interface in a smooth curve.

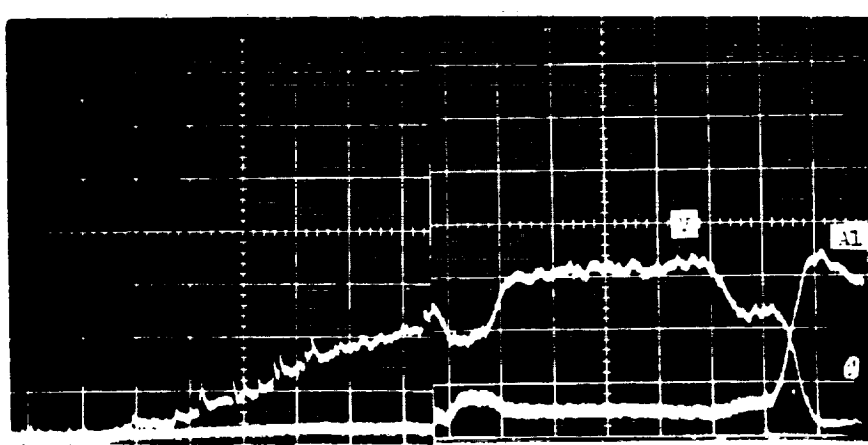
Sample D. Aged 1000 hours at 1200°C
Line Profiles, Al and V, 800X

Figure 94. Braze Analysis Data. Braze System 9M
(Cb-1Zr/64V-34Cb-2Zr/Mo/Al₂O₃) brazed at 1860°C
for 1 minute.

Figure 93 also shows the Zr line profile for the D sample, and the presence of modest peaks at the mid-width of the braze is observed. More disturbing features, however, are the line profiles of Nb(Cb), V, and Al in this specimen. These are shown in Figure 94. There is a suggestion that a Nb-V-Al phase appears near the Al_2O_3 interface, because there is a distinct rise in the Nb(Cb) trace coupled with a drop in the V trace, and with both levels being about one scale division (nominally 12 microns) wide. At the same location, there is a small, but noticeable, increase in the Al profile height for about the same width. In addition, there is another region at the mid-width of the braze. Here the Nb(Cb) trace is flat at the same level as that at the Al_2O_3 interface, and the V and the Al trace levels are also the same as those at the interface. Thus, this is very strong evidence that the factor producing this set of perturbations in the traces involves the three elements. Zirconium does not appear to be involved, in that there is no peak in the Zr profile at the interface, although one of the two peaks at the mid-

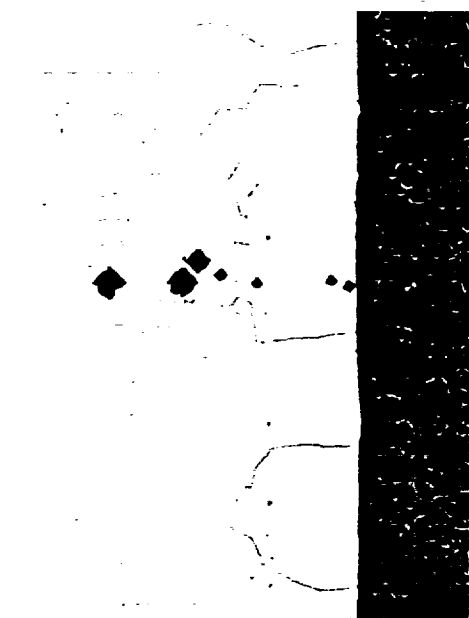
A. Micrograph, 100X

Figure 122. Aging Test Analysis Data: Braze System 14 W
(Cb-1Zr/V/W/Al₂O₃) brazed at 1860°C for 60 s.
Sample A aged for 1000 hours (3.6×10^6 s) at 1200°C;
Sample B aged for 5000 hours (1.8×10^7 s) at 1200°C.
